HUDSON RIVER BASIN  
PAPAKATING CREEK TRIBUTARY  
SUSSEX COUNTY  
NEW JERSEY

# LAKE NEEPAULIN DAM NJ 00282

## PHASE 1 INSPECTION REPORT NATIONAL DAM SAFETY PROGRAM

August, 1979

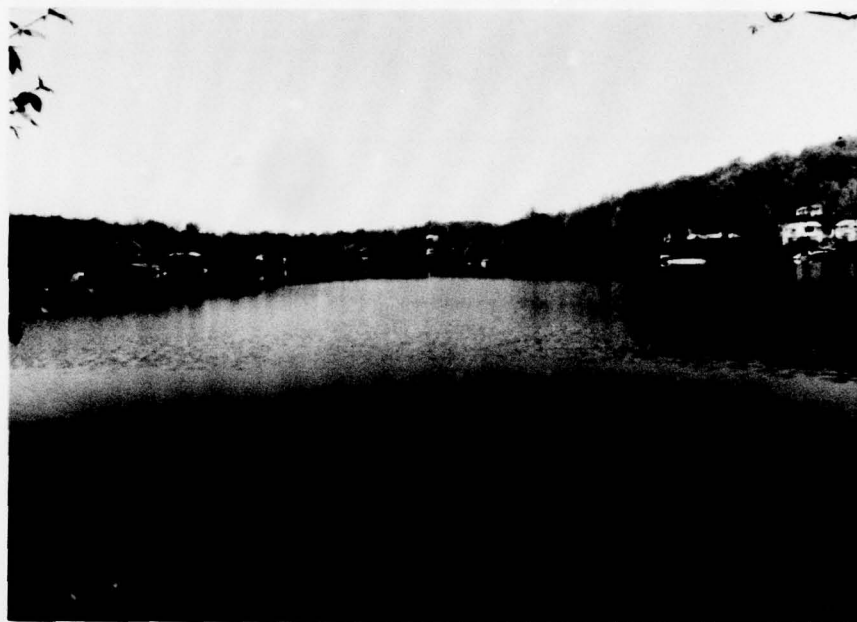
Photo No. 7 - View upstream from top of dam, showing lake and lakefront properties. Note moderate, wooded slopes.

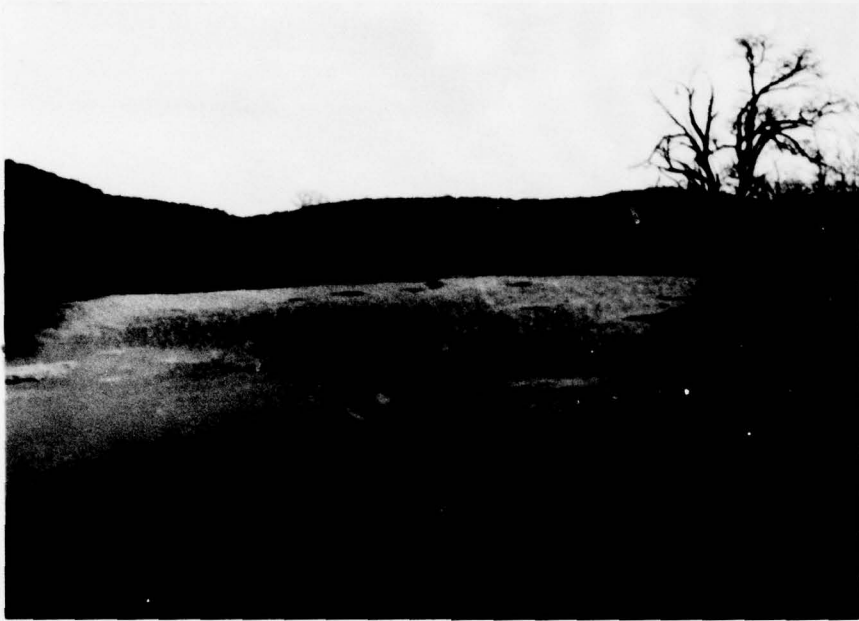
Photo No. 9 - Small pond located about 1/2 mile downstream from Lake Neepaulin Dam, where downstream channel widens out into a broad flood-plain. The view is upstream.

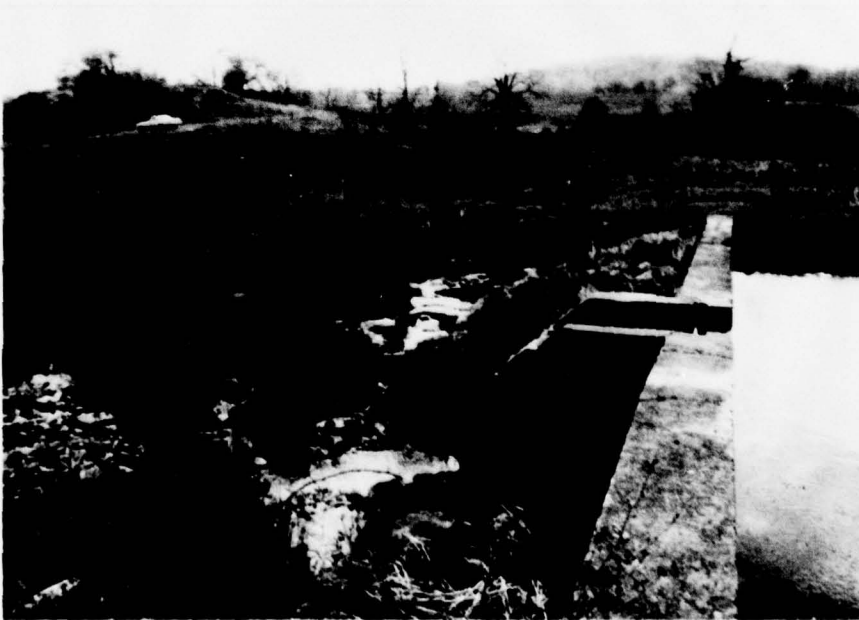
Photo No. 10 - Retaining structure of downstream pond.
